The Fire Resistance
Performance Of A
Loadbearing Timber
Floor Assembly
Protected by a
Plasterboard Ceiling
And Incorporating
Down Light
Assemblies, When
Tested in Accordance
with
BS 476: Part 21: 1987,
Clause 7

### WF Report No.

426806

## Collingwood Lighting Ltd

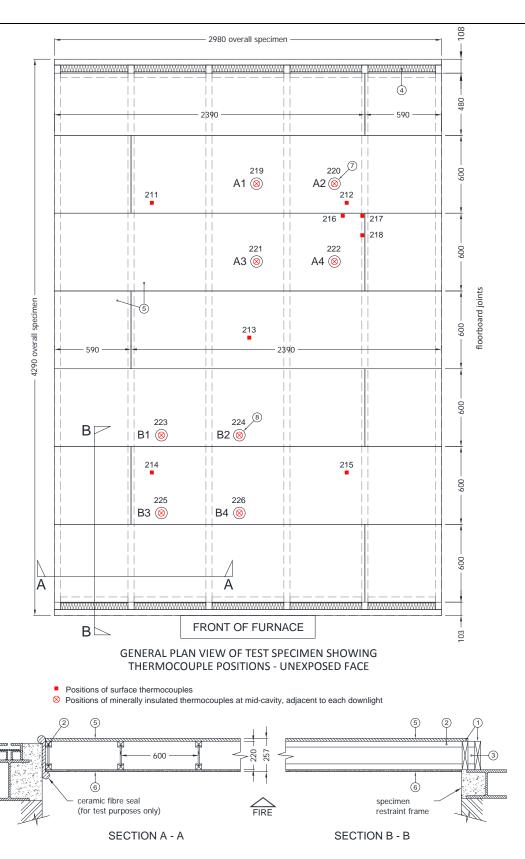
Figure 1 – General plan view of test specimen showing thermocouple positions - Unexposed face

Thermocouples were provided to monitor the unexposed surface of the specimen. The output of all instrumentation was recorded at no less than one-minute intervals. The locations and reference numbers of the various unexposed surface thermocouples are shown in Figure 1. Additional thermocouples were included for information purposes only. These additional thermocouples were installed within the assembly during its construction located at mid height of the cavity adjacent to the light fittings.

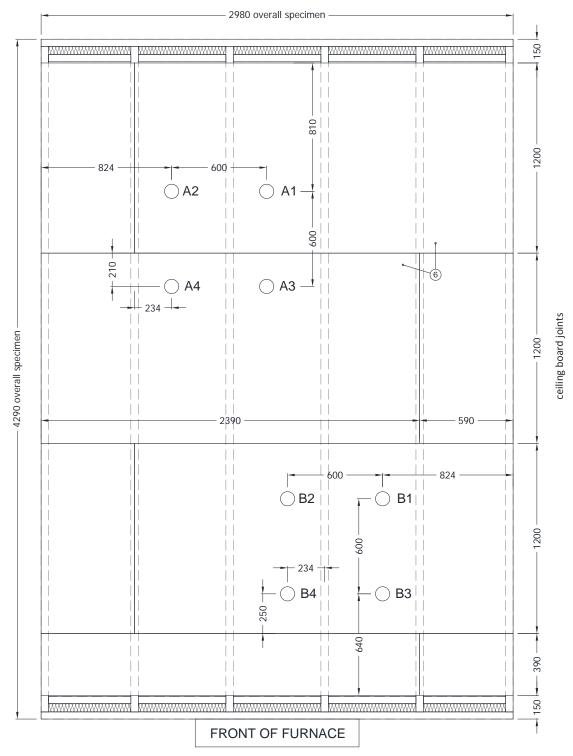
Figure 2 – General plan view of test specimen - Exposed face

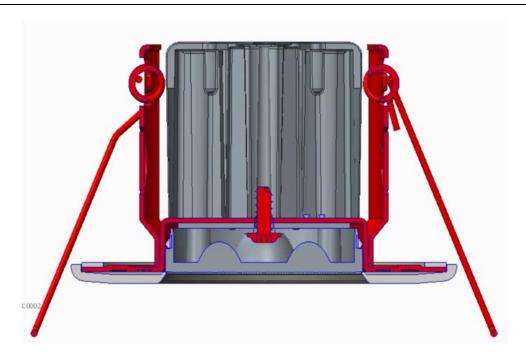
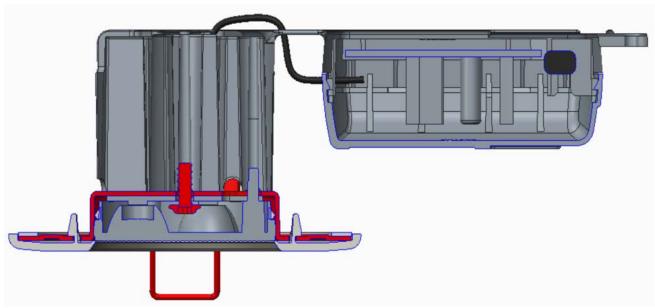
Figure 3 – Typical vertical sections through specimens A1 – A4: H2 Pro 550 (DLE472XXXX)

7. Specimens A1 - A4

Manufacturer : Collingwood Lighting Ltd.
Reference : H2 Pro 550 (DLE472XXXX)

Description : Fixed LED downlight fitted with H2 bezel. IP65 rated.

Material : Mild steel / V0 rated plastic insulation protector built in.

i. height : 49 mmii. overall diameter : 90 mmiii. cut-out diameter : 64 mm

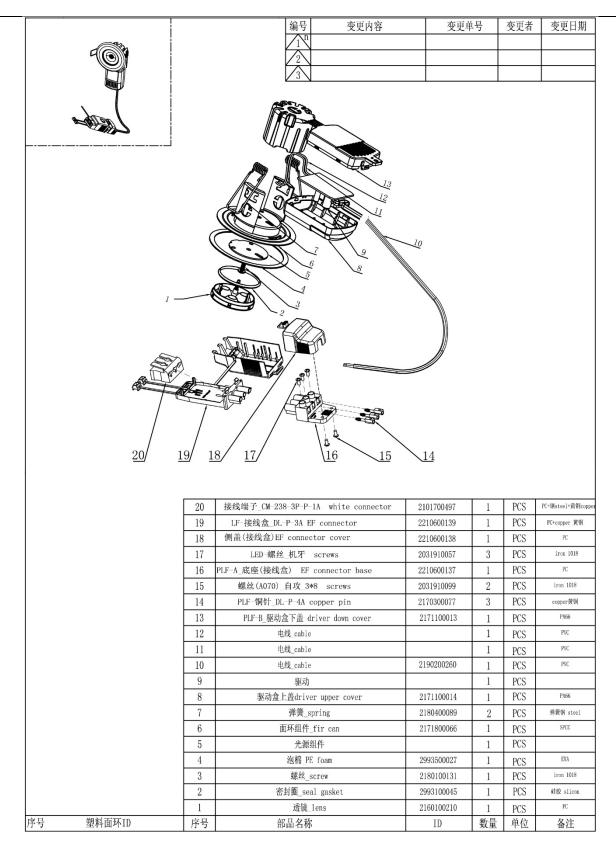
Figure 4 – Client's drawing: H2 Pro 550 (DLE472XXXX)

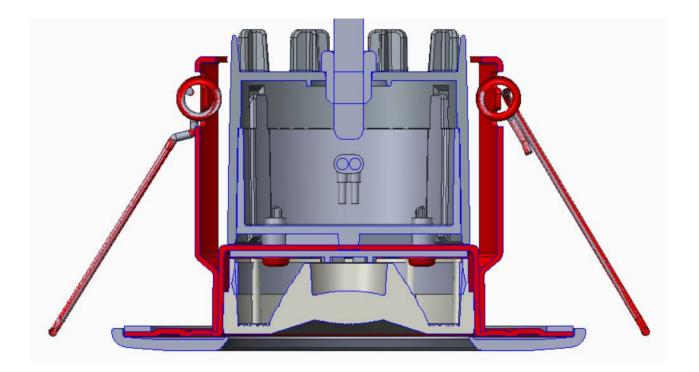
Figure 5 – Typical vertical sections through specimens B1 – B4: Newlec 400 (NLFRDLX)

8. Specimens B1 - B4

Manufacturer : Collingwood Lighting Ltd.
Reference : Newlec 400 (NLFRDLX)

Description : Fixed LED downlight fitted with H2 bezel

Material : Mild steel / V0 rated plastic insulation protector built in.

i. height : 60 mmii. overall diameter : 85 mmiii. cut-out diameter : 64 mm

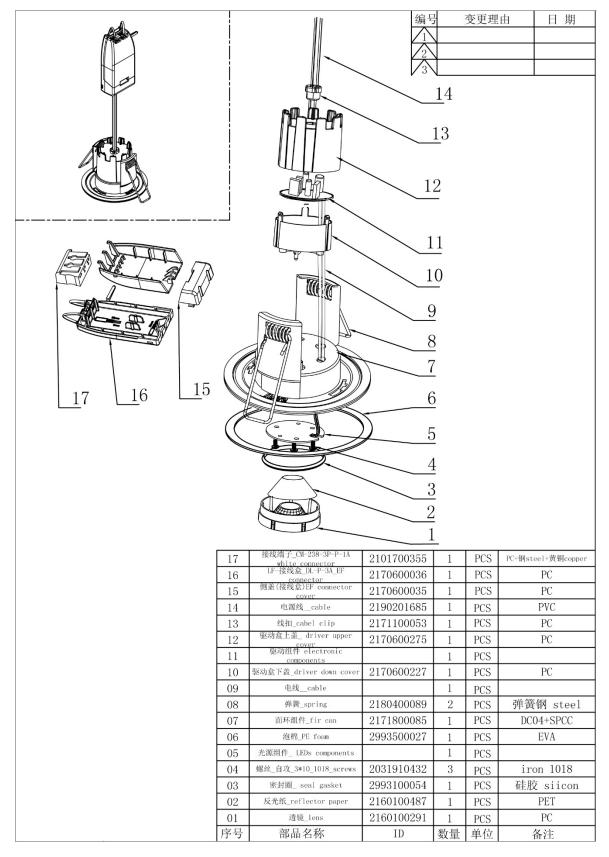
Figure 6 – Client's drawing: Newlec 400 (NLFRDLX)

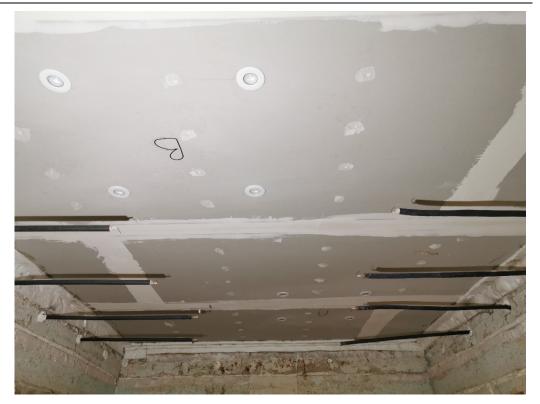
The exposed face of the floor assembly prior to test

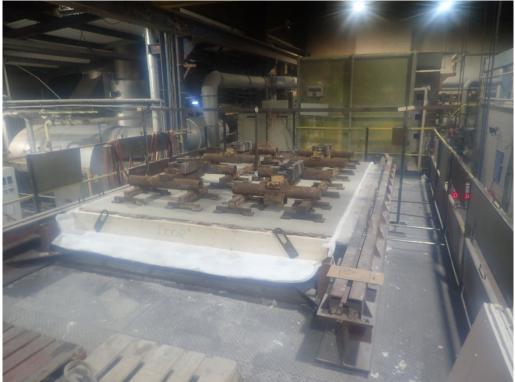
The unexposed face of the floor assembly prior to test

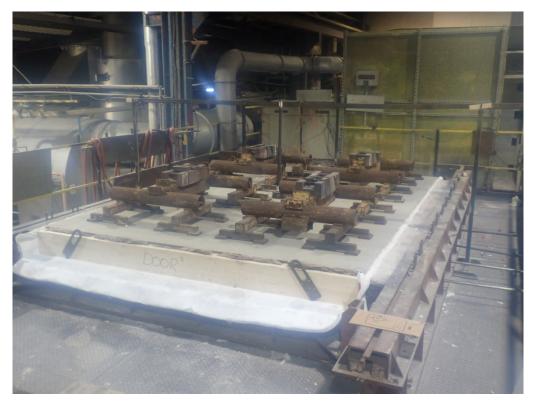
The unexposed face of the floor assembly after 10 minutes of testing

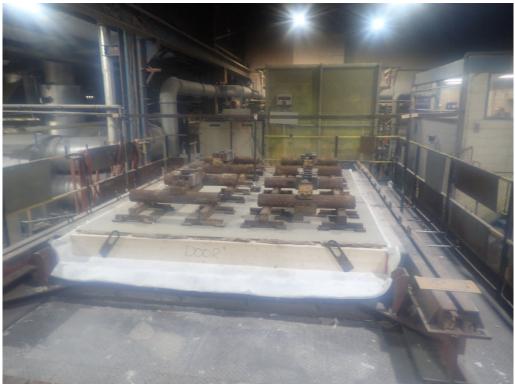
The unexposed face of the floor assembly after 20 minutes of testing

Tim	ie	All observations are from the unexposed face unless noted otherwise.	
-60	00	Load applied.	
00	00	The test commences.	
05	00	Intermittent flaming at the down light positions across the plasterboard on the exposed face.	
07	11	The plasterboard is discolouring on the exposed face; the joint coverings are beginning to fall away.	
10	22	Paper layer of plasterboard is burning away on the exposed face.	
12	00	Glowing at the plasterboard joints on the exposed face.	
14	00	Steam/smoke release from the supported ends of the floor construction.	
15	00	Plastic bezels of the down lights have burnt away.	
17	00	Long edges of the plasterboard begin to ripple, causing gaps to open up at the joints.	
18	30	Flaming at down light position 'A3' on the exposed face.	
20	00	Steam/smoke release increases at the supported ends of the floor construction.	
21	00	The gaps at the plasterboard joints are now around 20mm on the exposed face.

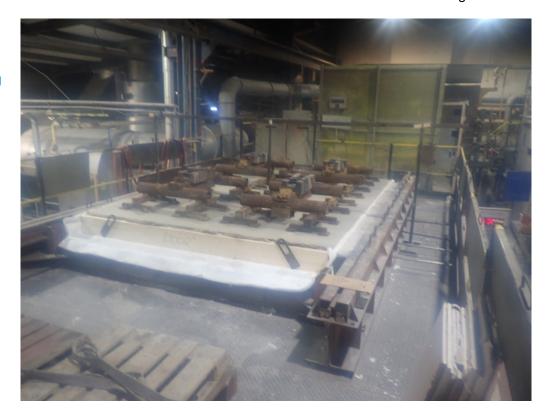
The unexposed face of the floor assembly after 30 minutes of testing

22	20	Flaming at all 'Specimen A' down light positions.	
27	30	Large section of plasterboard has fallen from the central section, intense flaming in the furnace.	
28	00	More plasterboard falls from centre of the exposed face.	
29	00	The joists are now exposed in the centre of the floor on the exposed face.	
30	00	The floor is bowing in its centre; inside of furnace is not visible due to intense flaming.	
31	00	Test discontinued for safety reasons.

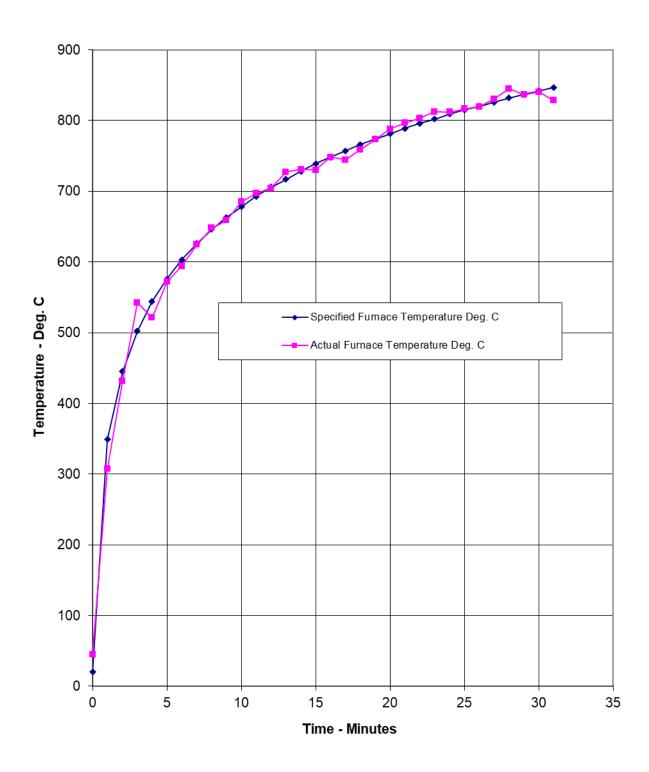
### Graph showing specified and actual furnace temperatures

Mean furnace temperature, together with the temperature/time relationship specified in BS 476:
Part 21: 1987

Time	Specified	Actual	
	Furnace	Furnace	
Mins	Temperature	Temperature	
	Deg. C	Deg. C	
0	20	45	
1	349	307	
2	445	432	
3	502	543	
4	544	521	
5	576	572	
6	603	594	
7	626	624	
8	646	648	
9	663	659	
10	678	685	
11	693	697	
12	706	705	
13	717	727	
14	728	731	
15	739	730	
16	748	748	
17	757	745	
18	766	759	
19	774	773	
20	781	788	
21	789	796	
22	796	804	
23	802	812	
24	809	812	
25	815	817	
26	820	820	
27	826	831	
28	832	845	
29	837	837	
30	842	841	
31	847	828

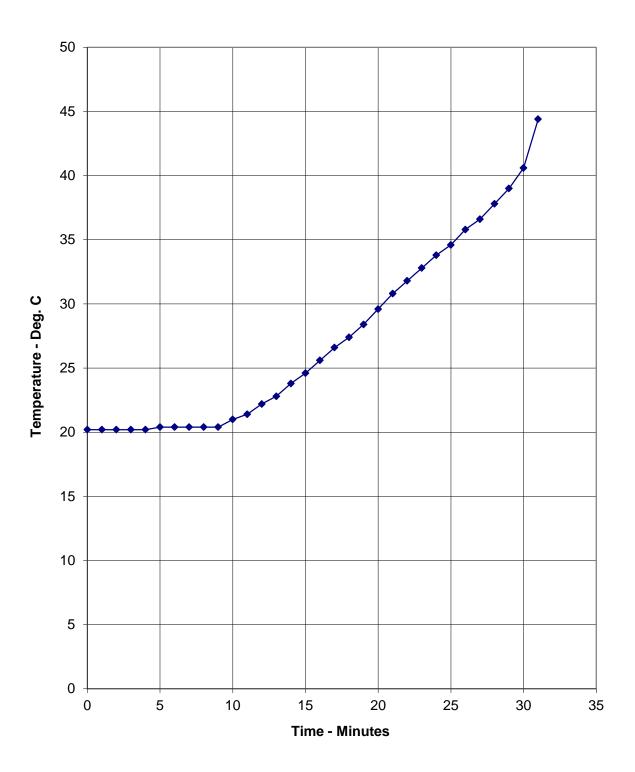
### Graph showing mean unexposed surface temperature of the floor assembly

### Individual and mean temperatures recorded on the unexposed surface of the floor

Time	T/C	T/C	T/C	T/C	T/C	Mean
	Number	Number	Number	Number	Number	
Mins	211	212	213	214	215	Temp
	Deg. C					
0	20	20	20	21	20	20
1	20	20	20	21	20	20
2	20	20	20	21	20	20
3	20	20	20	21	20	20
4	20	20	20	21	20	20
5	20	20	21	21	20	20
6	20	20	21	21	20	20
7	20	20	21	21	20	20
8	20	20	21	21	20	20
9	20	20	21	21	20	20
10	21	21	21	21	21	21
11	21	21	22	22	21	21
12	22	22	23	22	22	22
13	23	23	23	23	22	23
14	24	24	24	24	23	24
15	25	25	25	24	24	25
16	26	26	26	25	25	26
17	27	27	27	26	26	27
18	28	28	28	27	26	27
19	29	29	29	28	27	28
20	30	31	30	29	28	30
21	32	32	31	30	29	31
22	33	33	32	31	30	32
23	34	34	33	32	31	33
24	35	35	34	33	32	34
25	36	36	35	33	33	35
26	38	37	36	34	34	36
27	39	38	36	35	35	37
28	40	40	37	36	36	38
29	42	41	38	37	37	39
30	44	43	40	38	38	41
31	49	48	47	39	39	44

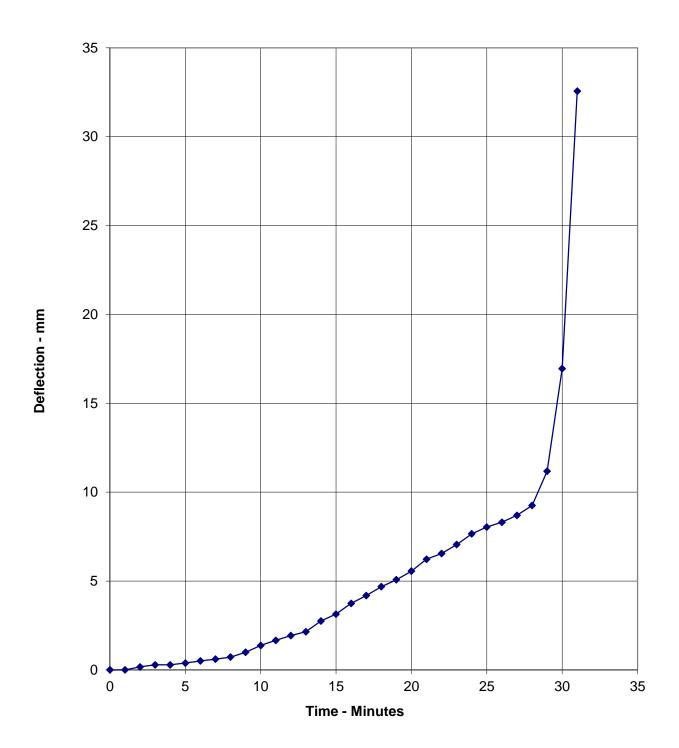
### Graph showing the central vertical deflection of the floor assembly during the test

### Deflection and rate of deflection of the floor assembly during the test

Time Central		Rate	
	Vertical	Of	
Mins	Deflection	Deflection	
	mm	mm/min	
0	0.000	0.000	
1	-0.218	-0.218	
2	0.168	0.386	
3	0.285	0.117	
4	0.285	0.000	
5	0.386	0.101	
6	0.504	0.118	
7	0.604	0.100	
8	0.722	0.118	
9	0.990	0.268	
10	1.376	0.386	
11	1.662	0.286	
12	1.930	0.268	
13	2.148	0.218	
14	2.753	0.605	
15	3.139	0.386	
16	3.743	0.604	
17	4.179	0.436	
18	4.683	0.504	
19	5.069	0.386	
20	5.556	0.487	
21	6.227	0.671	
22	6.546	0.319	
23	7.050	0.504	
24	7.654	0.604	
25	8.040	0.386	
26	8.309	0.269	
27	8.695	0.386	
28	9.248	0.553	
29	11.179	1.931	
30	16.953	5.774	
31	32.563	15.610

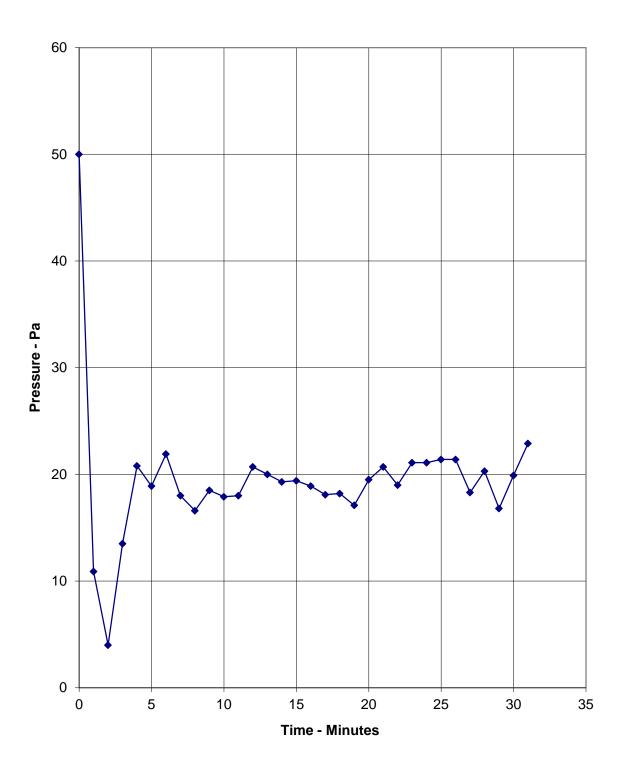
### Graph showing recorded furnace pressure 100 mm below the underside of the floor assembly

After the first five minutes of testing and for the remainder of the test, the furnace atmospheric pressure was controlled so that it complied with the requirements of BS 476: Part 20: 1987, Clause 3.2.2 (including allowance for transient occurrences in-line with Clause 12(I)). The calculated pressure differential relative to the laboratory atmosphere at a position 100 mm below the underside of the assembly was 20 (±2) Pa
